SERVICE BULLETIN

GREAT LAKES AIRCRAFT

SB-GL12-01R

HORIZONTAL STABILIZER SPAR INSPECTION

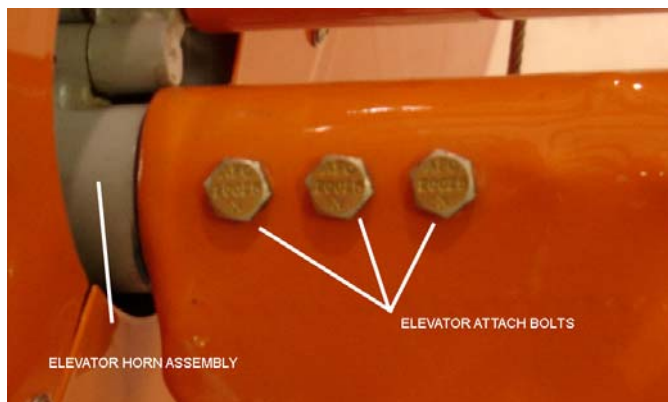
Fig. 1

1. Uninstall left and right elevators by removing the three AN3-16A elevator attach bolts securing each elevator to the elevator horn assembly (see fig. 1) and sliding the elevator outboard until disengaged from the hinge pins and the elevator horn assembly.

Re-install the left and right elevator assemblies by sliding the elevator over the elevator horn assembly and engaging the hinge pins. Install the three AN3-16A elevator attach bolts (Fig 1).

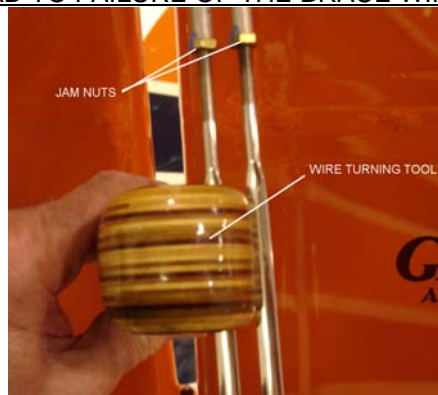
Fig. 2

(a) Relieve tension on the upper stabilizer brace wires on both sides of the vertical fin by first loosening the jam nuts at each end of each of the four streamline wires. Using a tool designed for adjusting streamline wires, engage the flattened section of the wire as near to the round section as possible at each end and turn to loosen each wire 4 full turns. **IMPORTANT: DO NOT USE ANY TOOL THAT WILL MARK OR SCRATCH THE SURFACE OF THE WIRE. DOING SO CAN LEAD TO FAILURE OF THE BRACE WIRE.** (See fig. 2)

Re-tension the tail brace wires. Following the instructions in **INSPECTION PROCEDURE** A.2.(a) above with regard to the handling of brace wires, tighten each 4 full turns and set the jamb nuts.

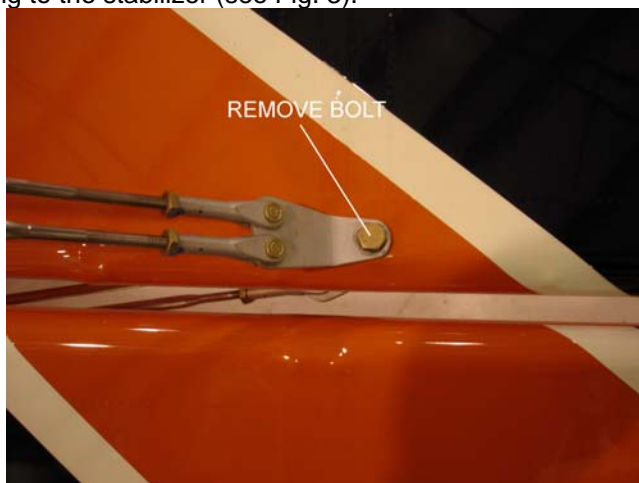
Fig. 3

- (b) Remove the AN4 bolt through the stabilizer rear spar securing the brace wire fitting to the stabilizer (see Fig. 3).

Attach the 10116-1 brace wire fitting (Fig 3) to the stabilizer rear spar tightening the AN4 bolt until the brace wire lug will not turn by hand then loosen the nut $\frac{3}{4}$ turn. The 10116-1 brace wire lug should now be free to move by hand. Re-install the inspection cover over the front stabilizer attach bolts top and bottom.

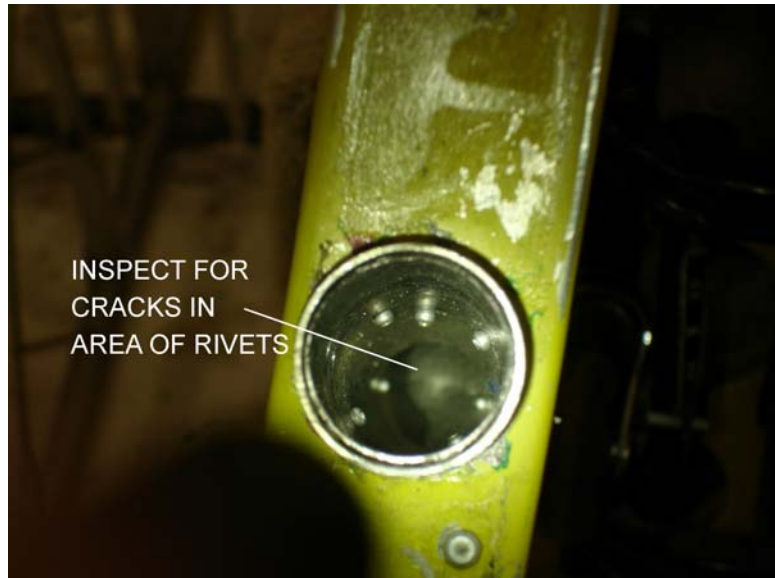
Fig. 5

- (d) Uninstall the left horizontal stabilizer as described in (c) above.
- (e) Clean the area to be inspected using a clean, soft bristle brush or clean lint free cloth. Using a strong light and small mirror, bore scope or remote inspection camera, inspect the inside of the front and rear spar tubes of both left and right stabilizers for cracks. Particular attention is to be directed to the area adjacent to the rivets 3 ½ to 4 ¼ inches in from the end of the tube (see Fig. 5).
- (f) If no cracks are found, proceed to the re-assembly section.

- B. If the inspection reveals any cracks in either spar, the stabilizer is not airworthy. Repairs must be accomplished before further flight using one of the following methods:
- (a) Install a new P/N 10102-1 Stabilizer Front Spar Assembly and/or P/N 63219-11 Rear Beam (Spar) Assembly as needed.
 - (b) Replace the defective stabilizer with a new Stabilizer Frame Assembly P/N 63219.
 - (c) Replace the defective stabilizer with a serviceable unit having an 8130-3 Airworthiness Release Certificate stating in Block 13 that SB-GL12-01R has been complied with.

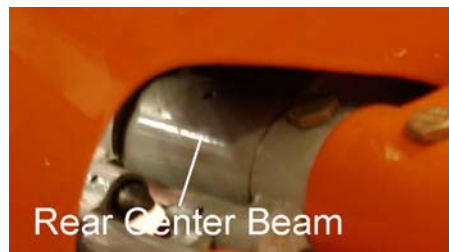
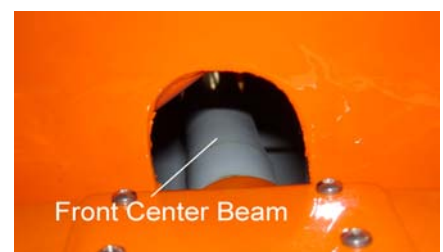
Fig. 6

- C. Prior to re-installing the stabilizers, inspect the condition of the front and rear Center Beam Assemblies to insure that they are free to rotate and are well lubricated with WD-40 (Ref. page II-1 of the Great Lakes Maintenance and Rigging Manual Model 2T-1A). (See Fig 6)
